KENTUCKY INDIVIDUAL BUILDING SURVEY FORM

RESOURCE # JF-2777

1. **NAME OF RESOURCE** (how determined): Fern Creek Wesleyan Camp Dining Hall/Dormitory
2. **4 / Original or later significant uses of the property**

3. **ADDRESS/LOCATION:**
7009 South Watterson Trail
Louisville, Kentucky 40291

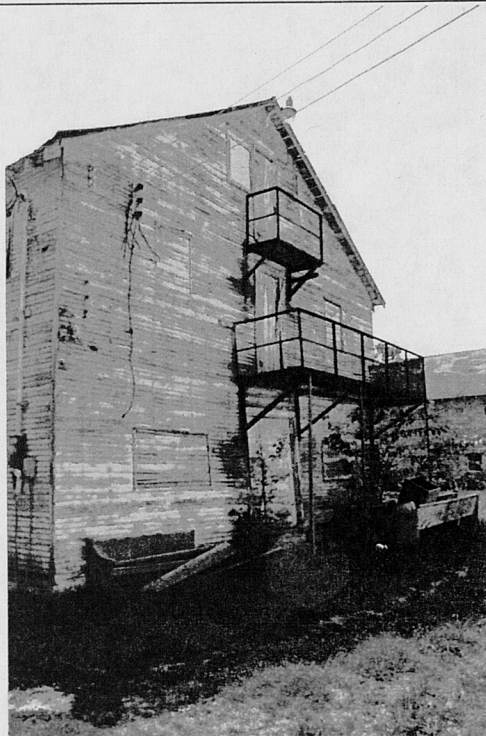
JF2777_1: West elevation, looking SE.

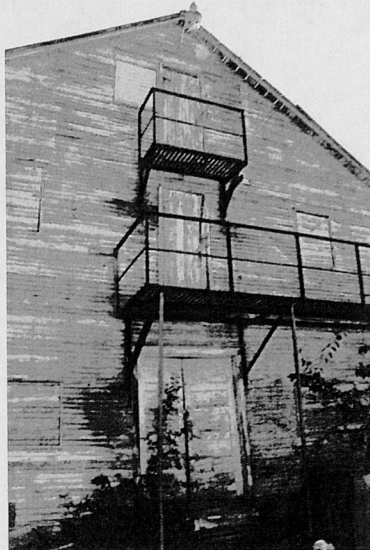
The west and east elevations contain the main entryways into this building. These elevations feature a three bay window-door-window arrangement on the first and second floors. Portions of a metal stair remain on the west elevation. This stair may have originally risen from the southern corner of the west elevation to the second floor central door. There may also have been access to the third half-story from this stair. Currently there is no access to either the third half-story or second floor from this exterior stair. The east elevation no longer has an exterior access stair but evidence of one remains as shadow lines on the building. The west elevation may well have been the main entryway, as it features access to the first floor through a set of decorative wood panel doors. All other doors are wooden battened doors that resemble those found on agricultural outbuildings.

JF2777_2: Close-up of west elevation stair, looking SE.

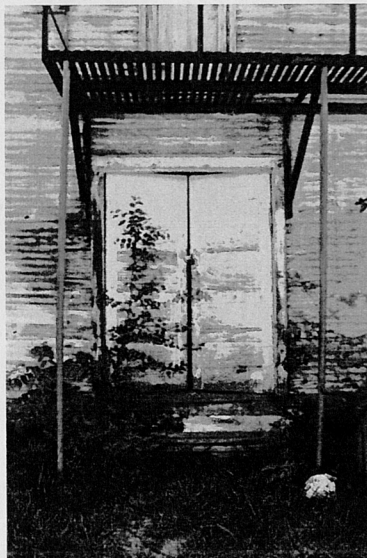
JF2777_3: Close-up of west elevation first floor entryway, looking east.

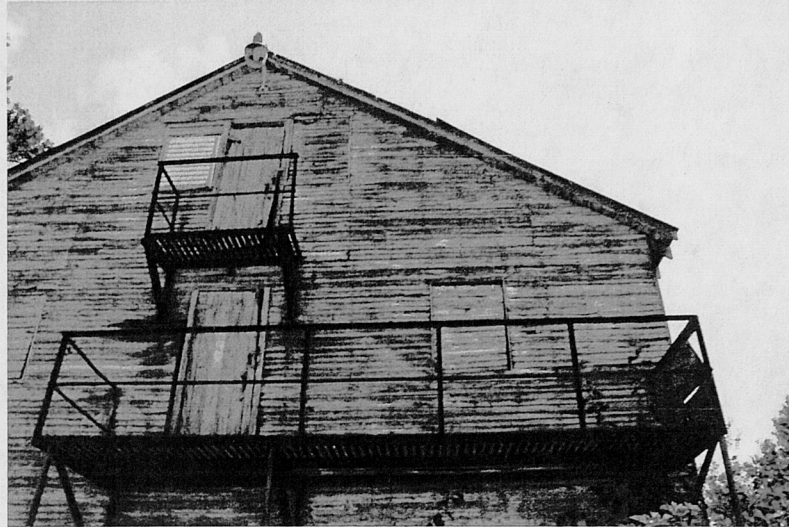
JF2777_4: Close-up of second and third half-story, looking NE.

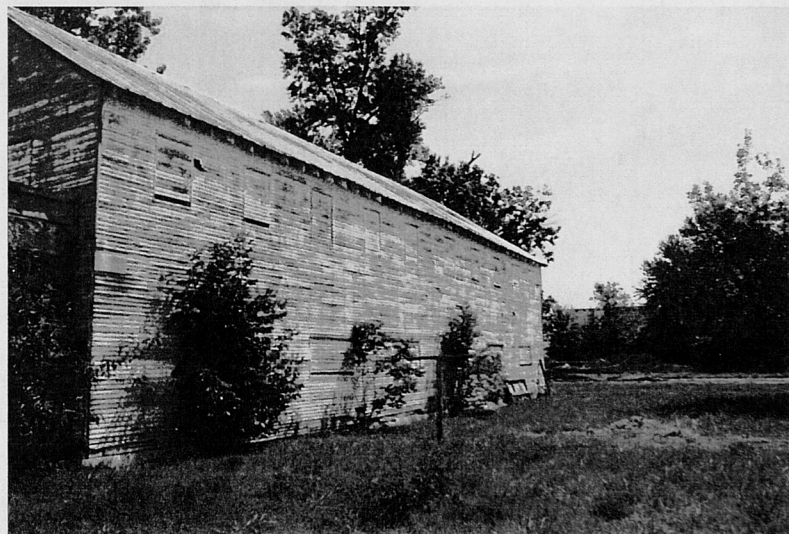
The building's south elevation features ten vertically-hinged shutters on the second floor and six awning-style shutters on the first floor. As access was not available to the second floor of this building, it is unclear if each of these upper-story shutters corresponded to a single dorm room. The first floor shutters light the dining hall space. The north elevation features the exact same design.

JF2777_5: South elevation, looking NE.

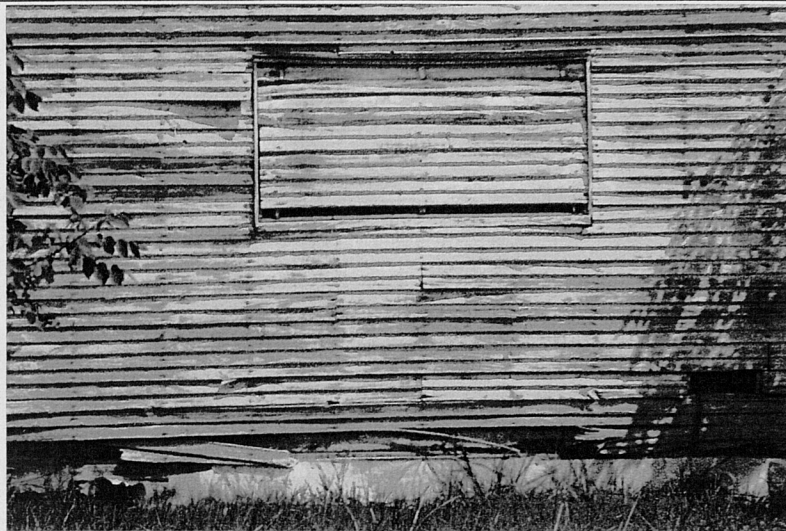
JF2777_6: Detail of hinged awning shutter on south elevation, looking north.

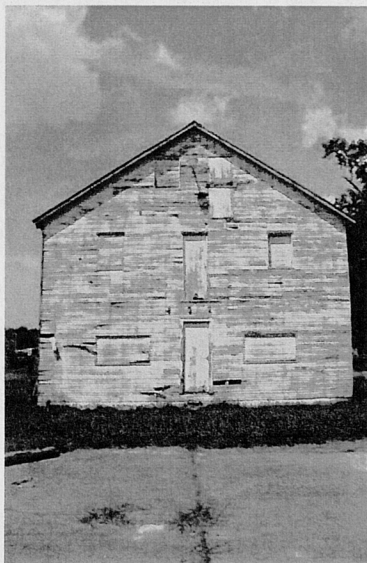
JF2777_7: East elevation, taken from basketball court facing west.

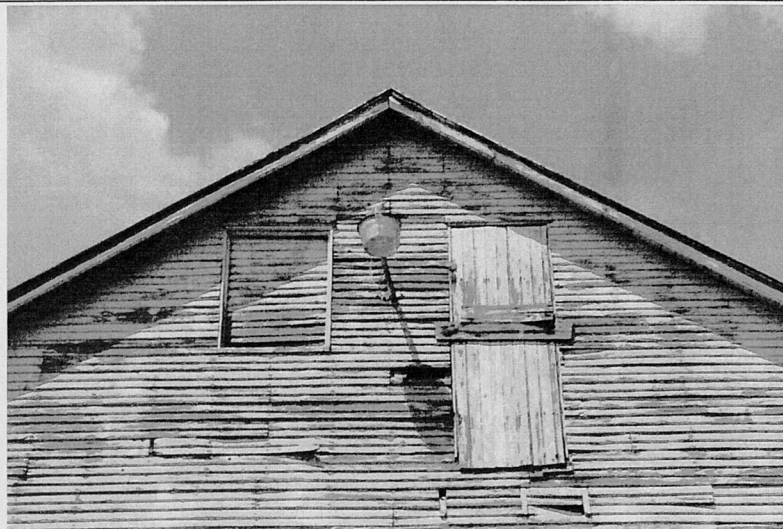
JF2777_8: Upper story access and window on east elevation, facing west.

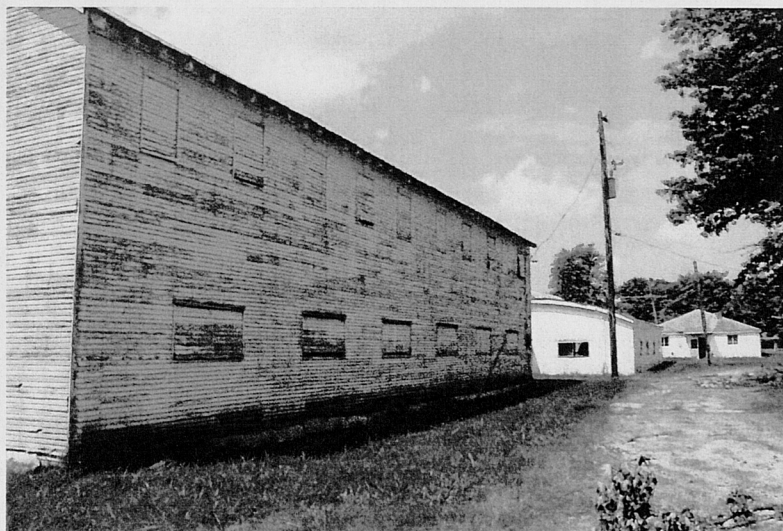
JF2777_9: North elevation, looking SE toward rear of dining hall/kitchen (JF-2775).

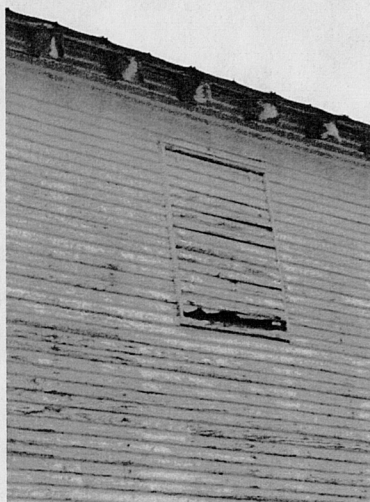
JF2777_10: Upper story hinged shutter on north elevation.

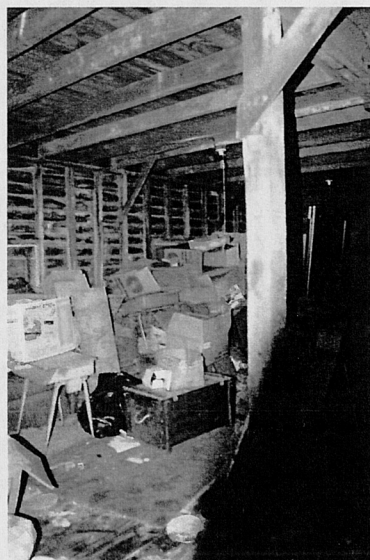
Access on the interior was limited to the first floor, as the interior stair was not safe to traverse. The first floor is characterized by what appears to be a three-aisle arrangement. The interior first floor has wood flooring, open wooden ceilings, and open stud walls with corner support bracing. As far as could be seen, the walls were unpainted. The overall appearance on the interior is of an agricultural building. It is assumed that the builders were well-acquainted with barn-building.

JF2777_11: Interior of building. Photo taken from front entrance (west elev) looking toward north wall.

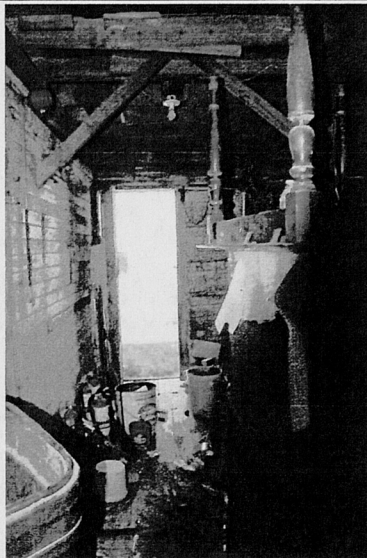
JF2777_12: Interior of first floor looking toward west elevation entryway.

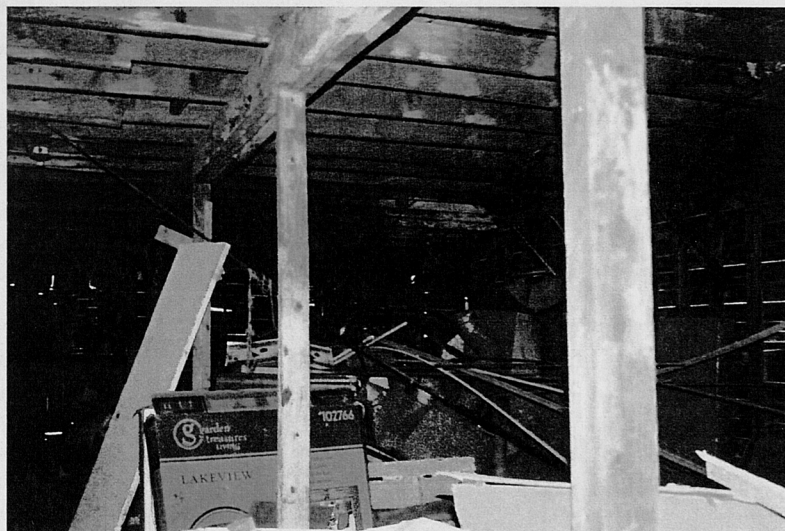
JF2777_13: Interior of first floor, looking toward south wall.

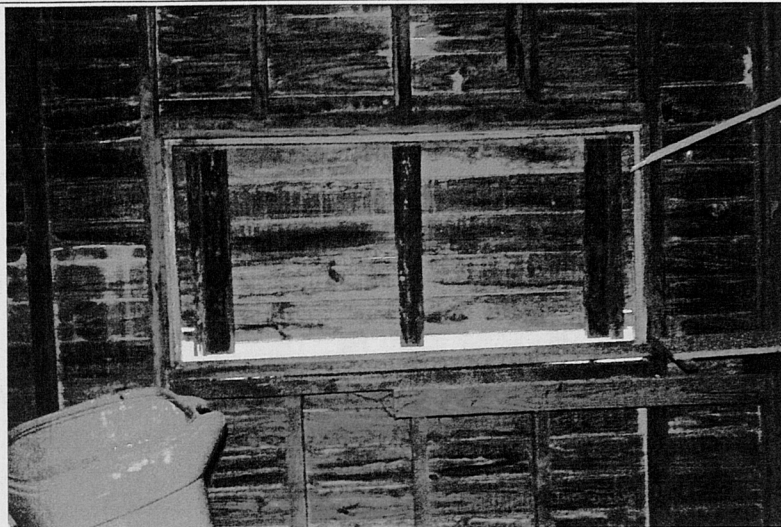
JF2777_14: Shutter on the north wall, looking NE.

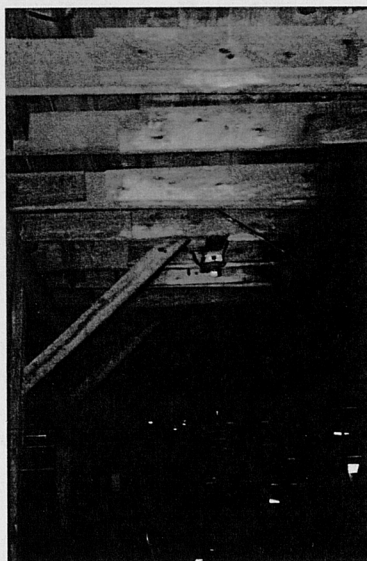
JF2777_15: Ceiling on first floor near center of space, looking toward east wall.

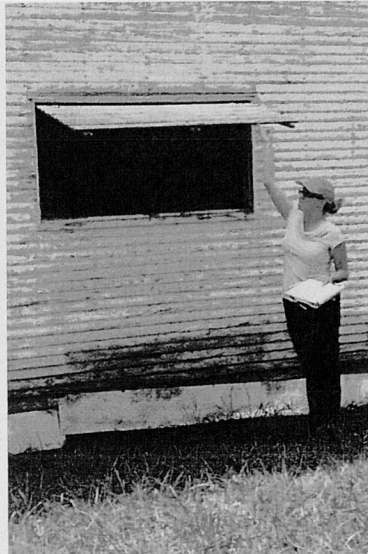
JF2777_16: A lovely photo of the author demonstrating how the shutters worked. No doubt, there were originally interior support bars to prop them open.

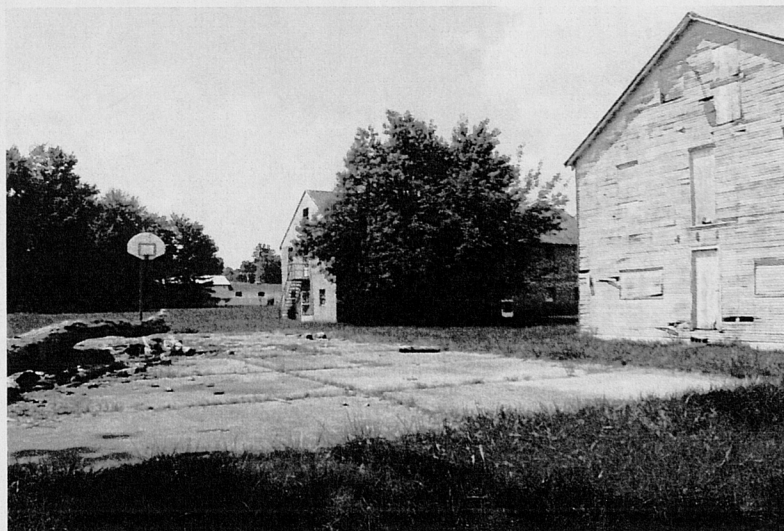
JF2777_17: The old dining hall/dorm (JF-2777) and the Girl's Dorm (JF-2776), looking south.
